Operation and Maintenance Report  
January 2019 to December 2019

## McCormick and Baxter Superfund Site

Portland, Oregon  
ECSI Site No. 74

**July 22, 2020**  
**150-002-005/Task 3**

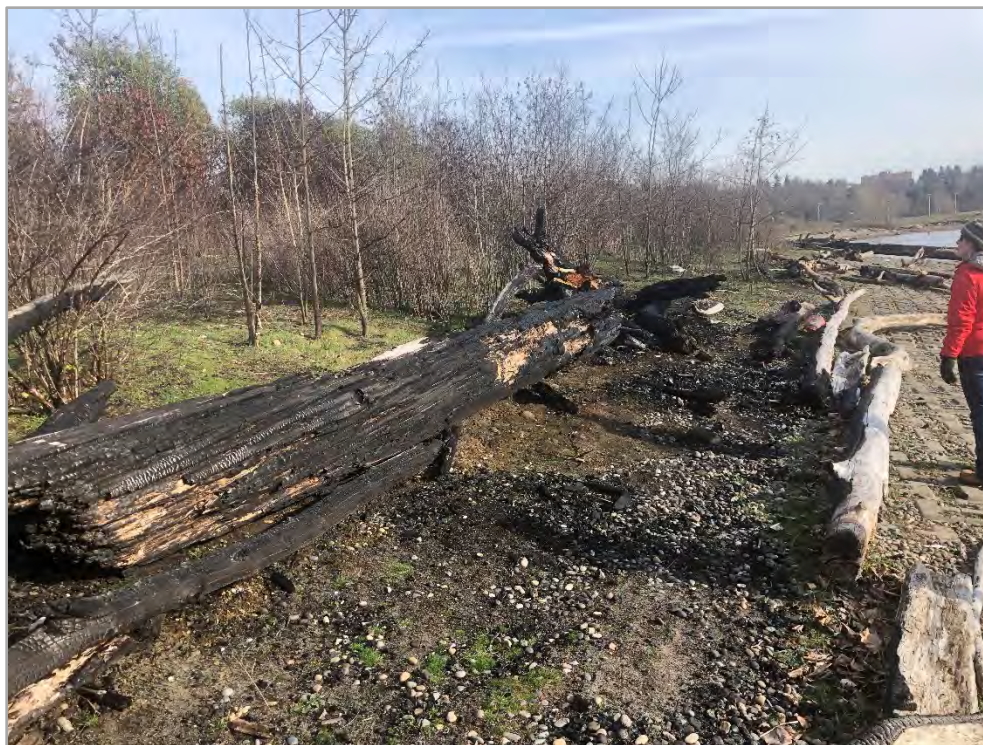
**Photograph A3:** Driftwood tree trunk burned in July 2018 riparian fire burn area (February 2019).

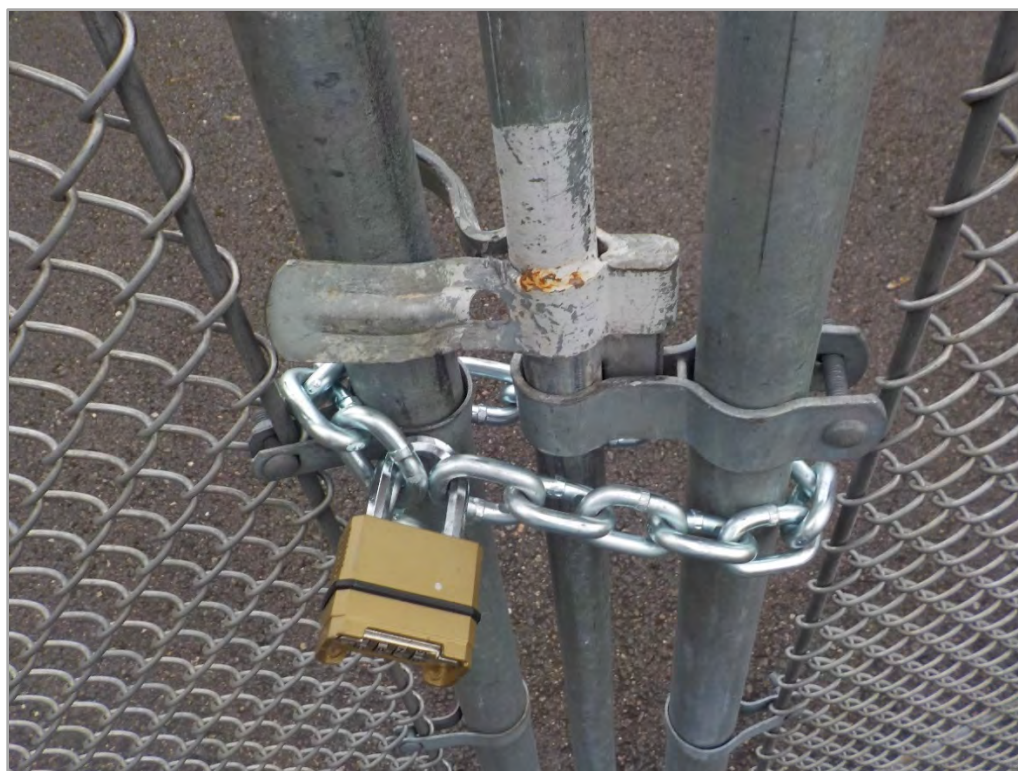
**Photograph A6:** Replacement lock with hardened steel shackle on gate to paved storage area after prior lock was cut off (March 2019).

road outside the perimeter fence along the riparian area; and replacement of a cut lock (Appendix A, Photograph A6) and repairs to the main gate shackle which had been bent by unauthorized site entry. During the site visit, it was identified that two gas vents, GV-1 and GV-4, were missing vault boxes (Appendix A, Photograph A7) and required additional supplies to implement repairs.

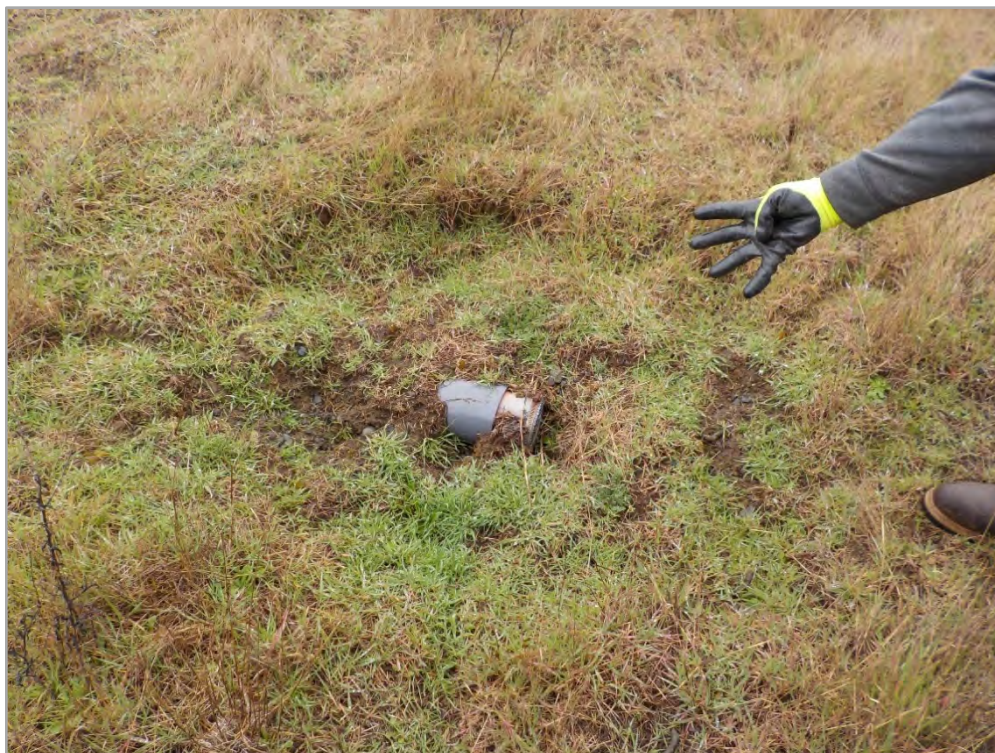
**Photograph A7:** Gas vent GV-4 with missing vault (March 2019).

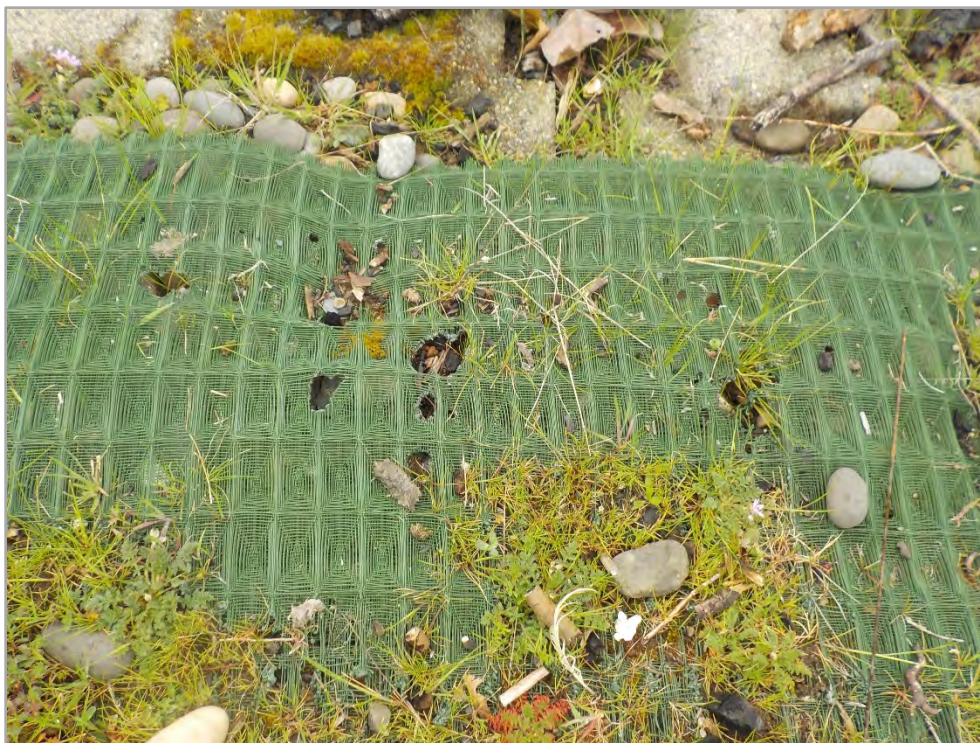
with trees developing new buds in the latter half of 2019. Burned holes in the TRM were monitored throughout the year and appeared stable without increases in size (Appendix A, Photograph A9).

**Photograph A9:** Burned holes in TRM following July 2018 riparian area fire. Holes appear stable and are not increasing in size (April 2019).

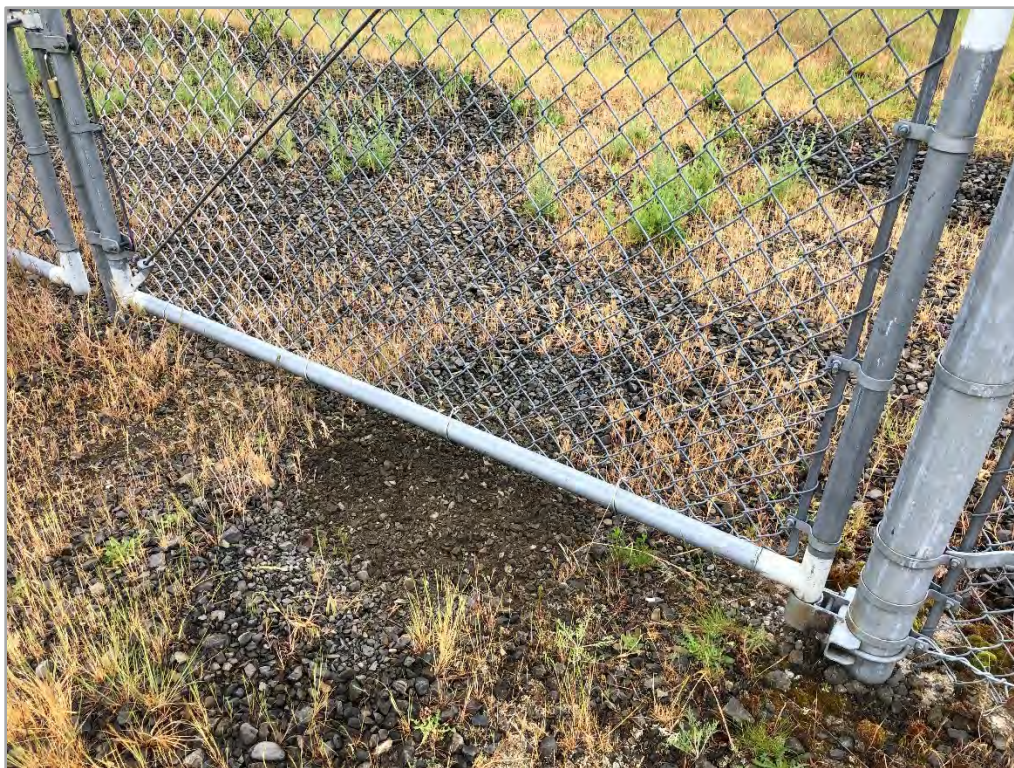
**Photograph A11:** Filled animal burrow beneath access gate in southwest corner of the site (May 2019).

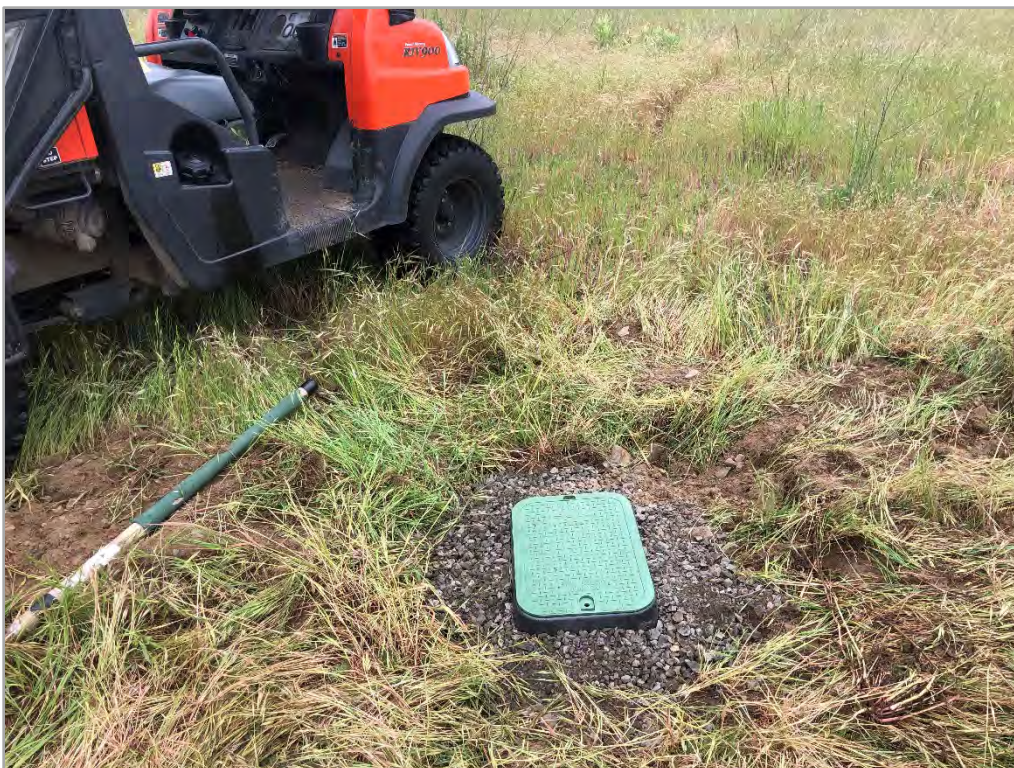
**Photograph A12:** Completed installation of replacement vault box for gas vent GV-4 (May 2019).

A vegetation inspection was performed on May 17, 2019, concurrently with O&M activities. The vegetation inspection results are described in detail in Section 5.3.2 and identified several noxious plant species in both the upland and riparian areas of the site. Replacement of the missing gas vent vaults for GV-1 and GV-4 was completed as part of the O&M activities (Appendix A, Photograph A12).

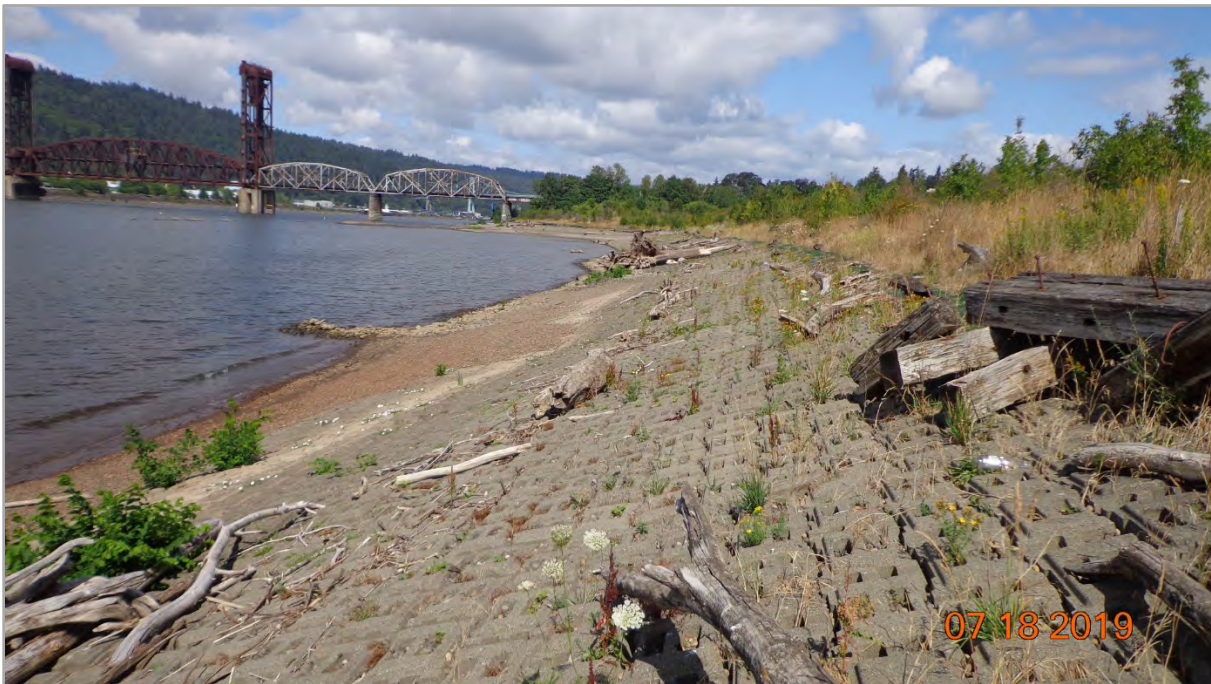
Habitat enhancement features, such as boulder clusters and sand cover as a biotic layer, are design elements of the sediment cap. Driftwood also provides habitat enhancement along the shoreline and in the riparian area above the shoreline. The distribution of sand cover over the ACB is similar to previous years. Originally, sand was placed over a large portion of the shoreline and Willamette Cove ACB armoring, but high river flow conditions and wakes from passing boats had washed sand from the ACB where the bank slopes are steeper. Rounded 1 ½-inch-minus gravel was placed within the ACB voids along a large portion of the shoreline and Willamette Cove in October 2012. The gravel has largely remained in place through 2019; however, some has washed down steeper shorelines and has settled onto lower ACB surfaces (Appendix A, Photographs A14 and A21).

**Photograph A14:** View facing northwest of the shoreline along the Willamette River (July 2019). Cover gravel washed from the upper slope of the ACB surface is visible along the waterline.

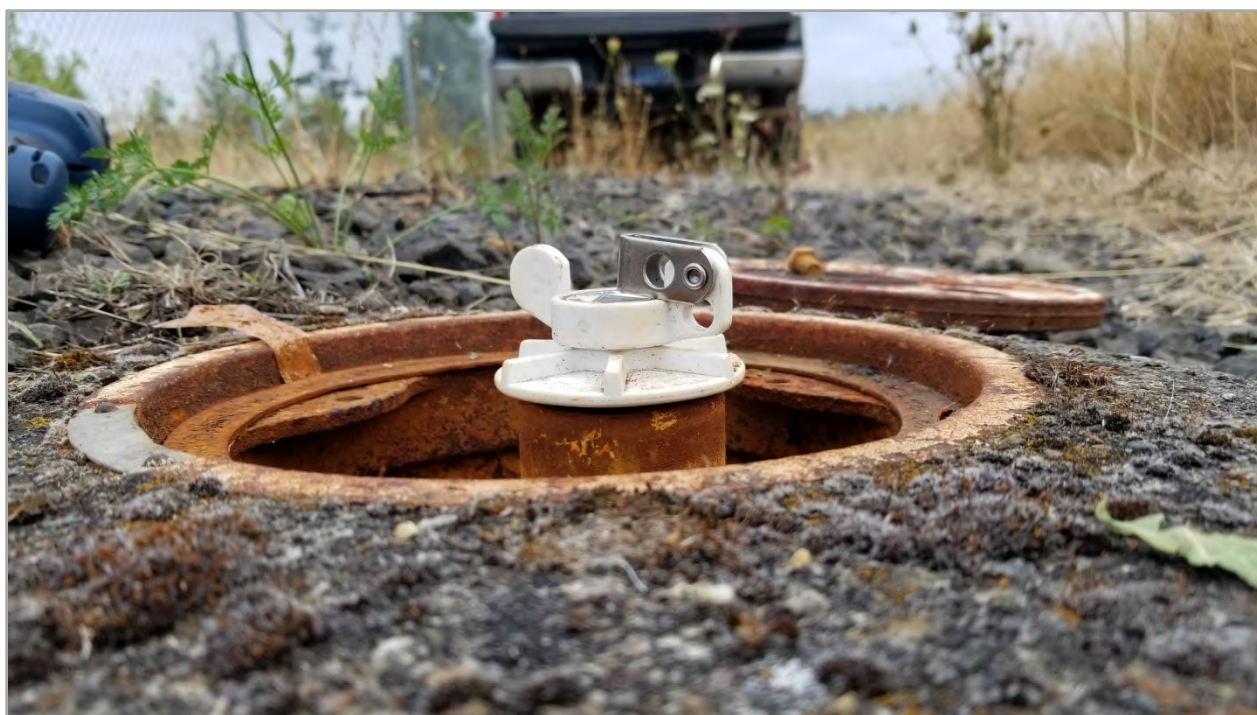
**Photograph A16:** MW-59s well casing and cap sticking above rim of well box prior to trimming (August 2019).

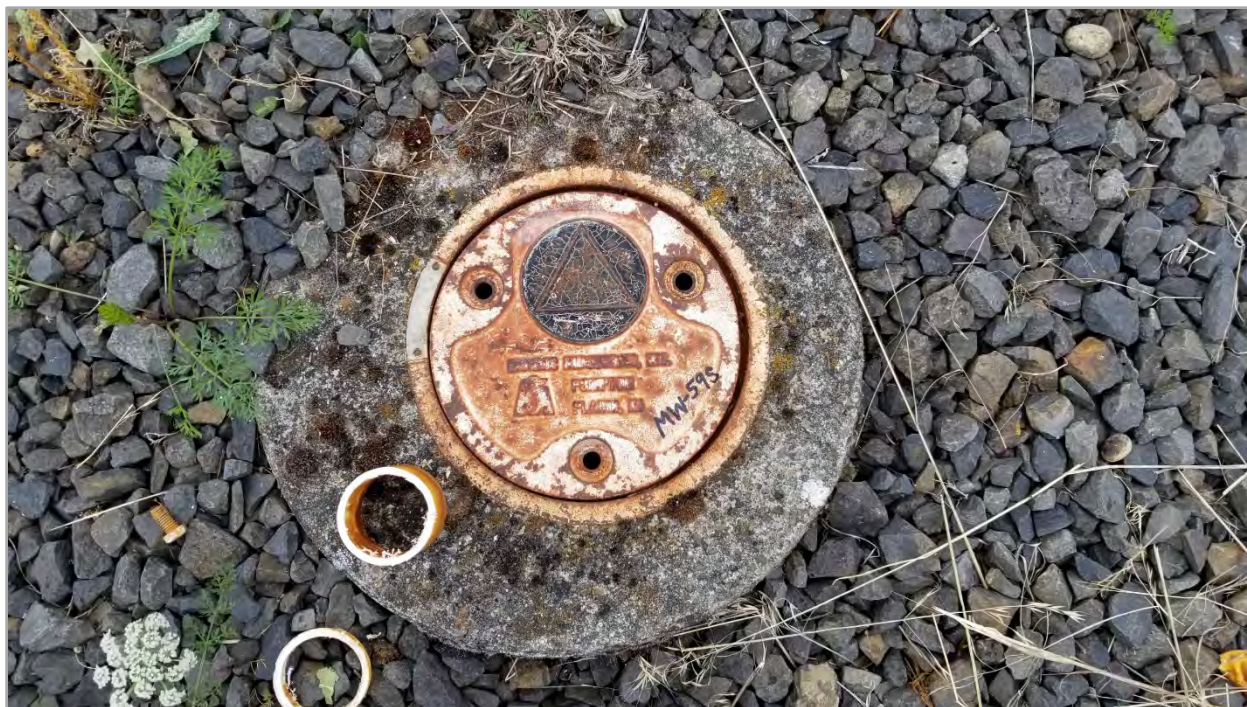
**Photograph A17:** Properly seated well box lid for MW-59s following trimming of the well casing by 2.125 inches (August 2019).

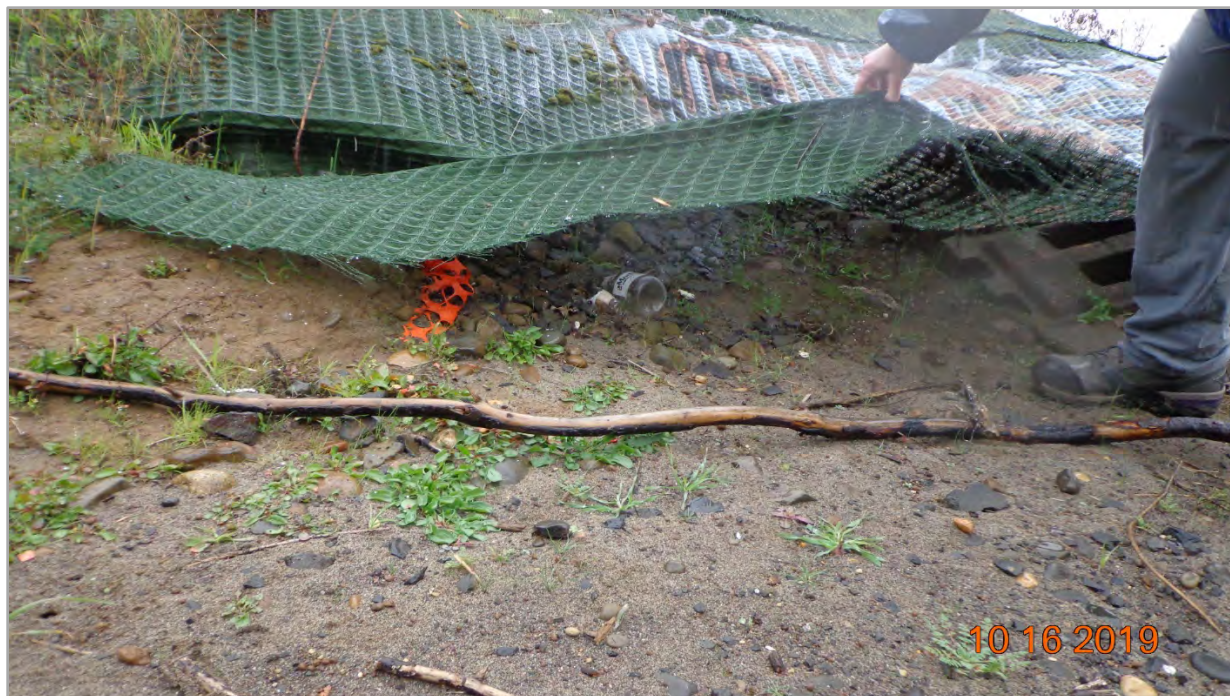
During the October 2019 quarterly site inspection, a minor amount of erosion was observed at the northwestern end of the turf-reinforced matting (TRM) at the upper edge of the ACB (Appendix A, Photograph A19), likely occurring only during very high water conditions of the Willamette River. The erosional area will be repaired during O&M activities for the site in summer 2020.

**Photograph A19:** Area of sand erosion under TRM along walking path near MW-37 well cluster (October 2019).

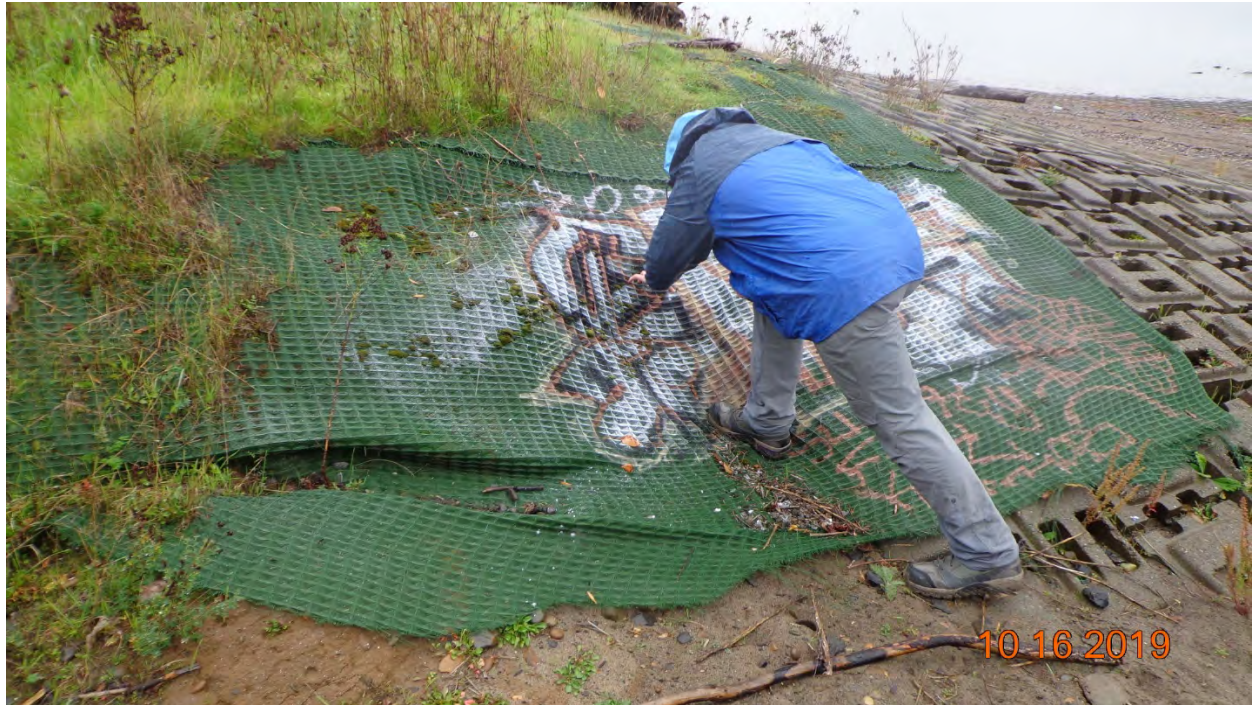
Photo 1: TRM at northern end of riparian area displaying signs of sagging.

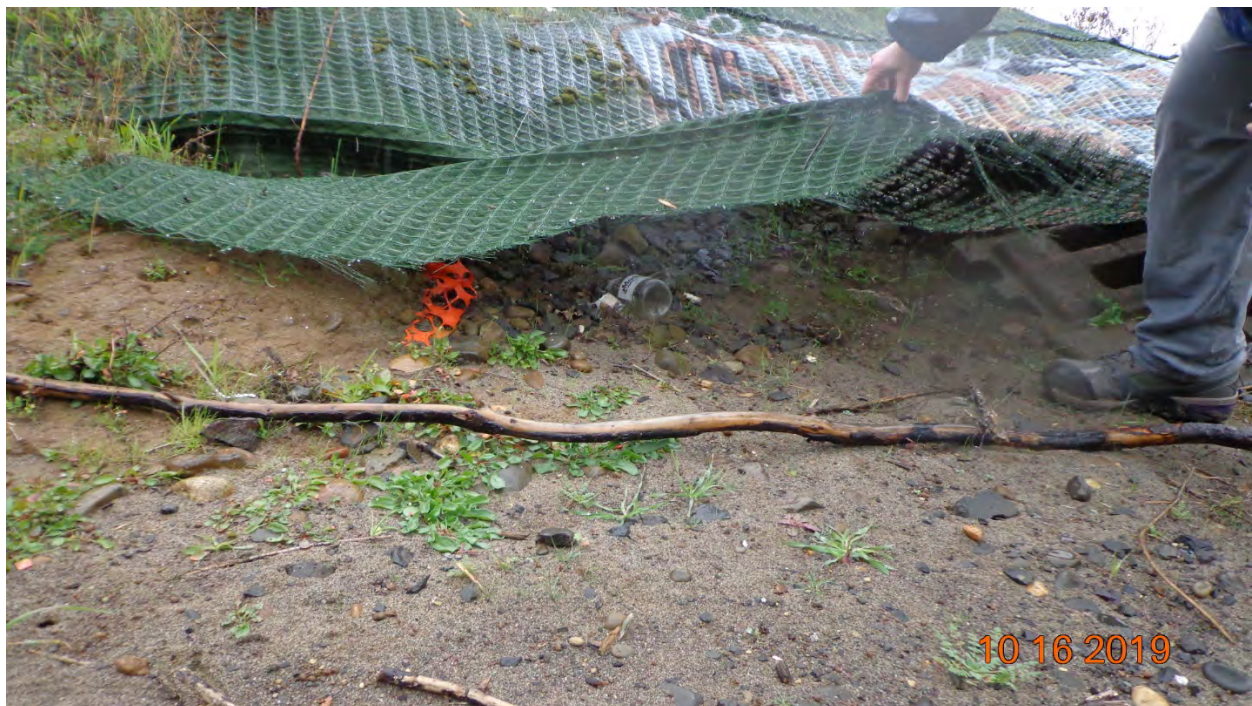
Photo 2: View of depression under TRM where sand appears to have washed out from under the corner of the mat.

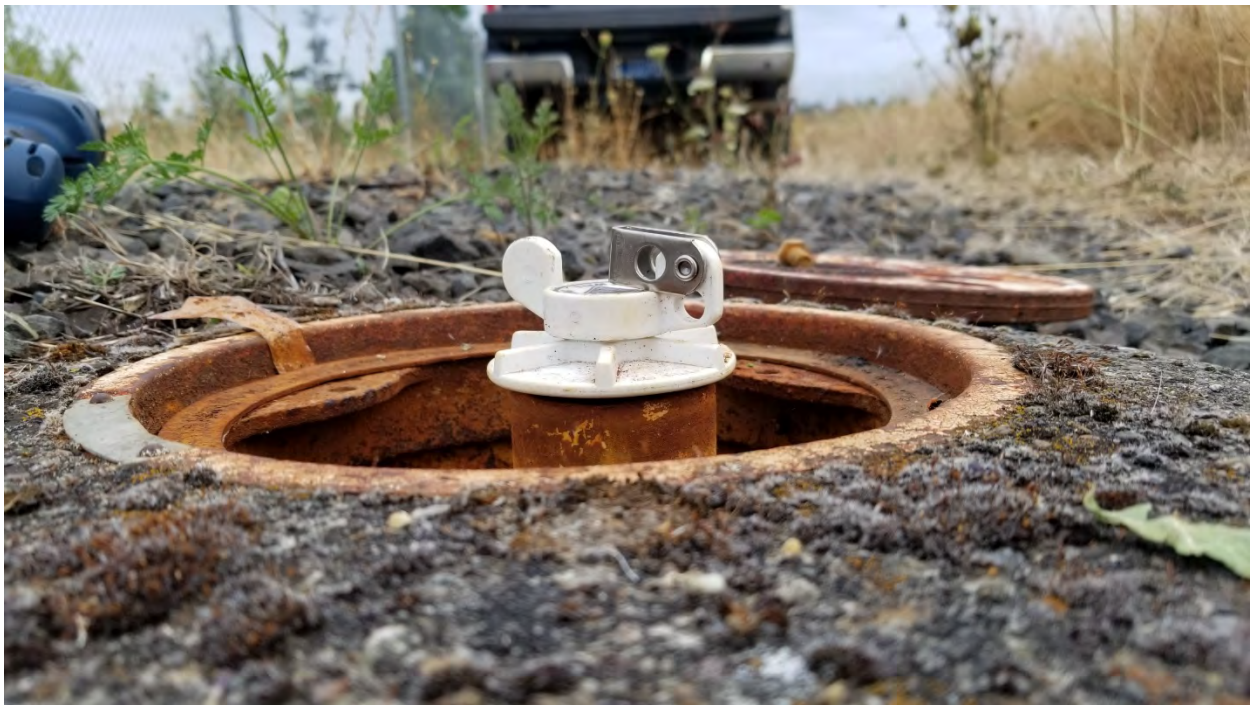
Photo 8: Well cap and casing for MW-59s protruding above the rim of the well box in the perimeter road.

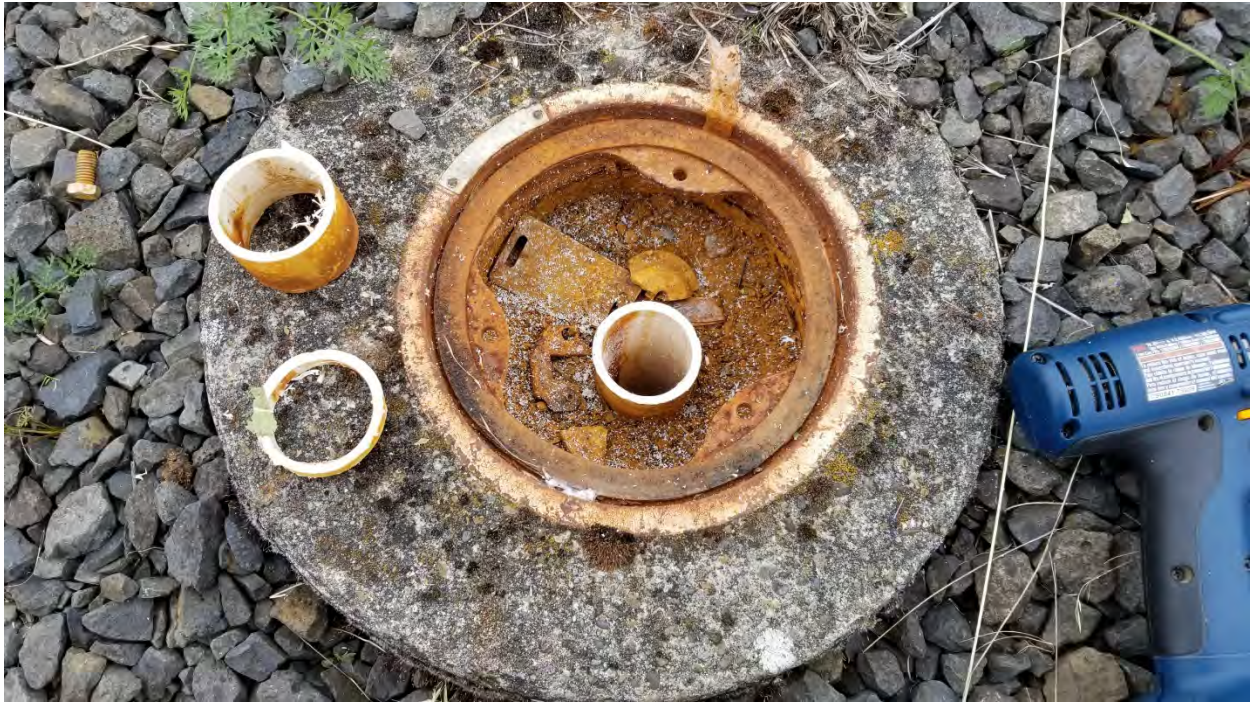
Photo 9: MW-59s well casing after removal of 3 inches using a power drill attached internal PVC pipe cutter.

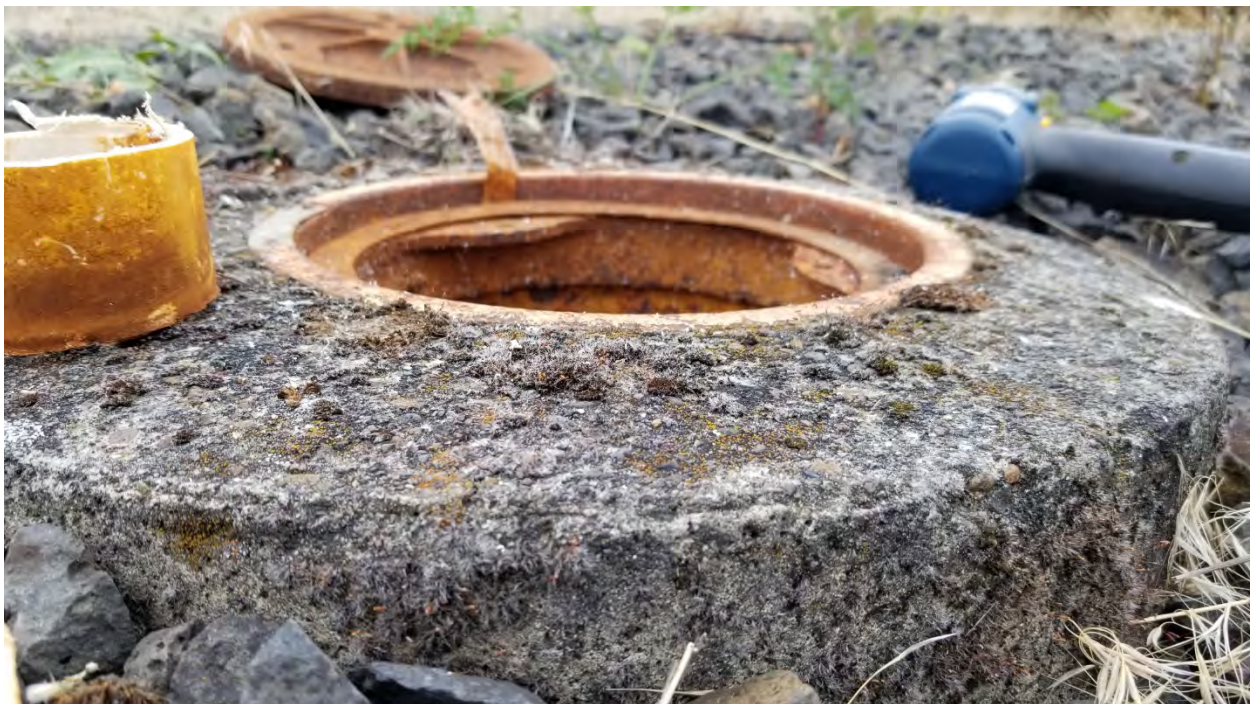
Photo 10: Well casing sitting below the rim of the well box after trimming.

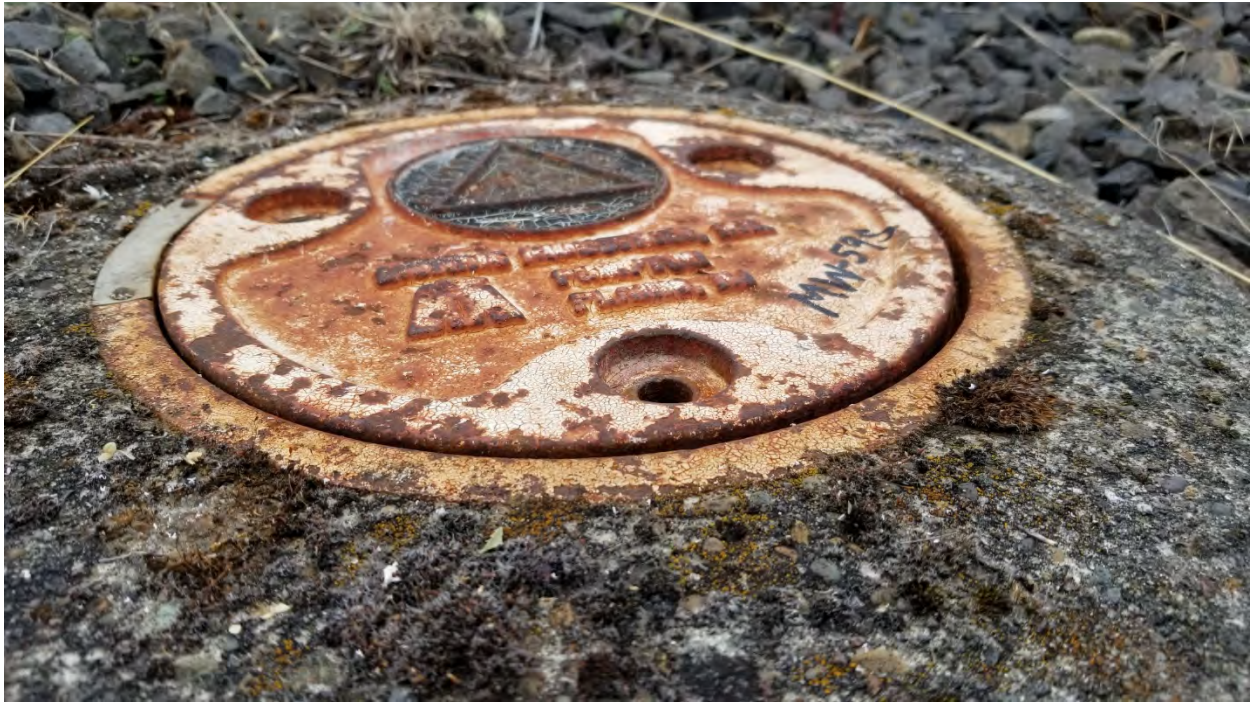
Photo 11: Well lid sitting correctly in well box after trimming of MW-59s casing.
